THE LOMA PRIETA, CALIFORNIA, EARTHQUAKE OF OCTOBER 17, 1989:  
STRONG GROUND MOTION AND GROUND FAILURE

MARINA DISTRICT

PERFORMANCE OF EMERGENCY-RESPONSE SERVICES  
AFTER THE EARTHQUAKE

By Charles R. Scawthorn and Keith A. Porter, EQE Engineering and Design; and  
Frank T. Blackburn, PWSS Co., Ltd.

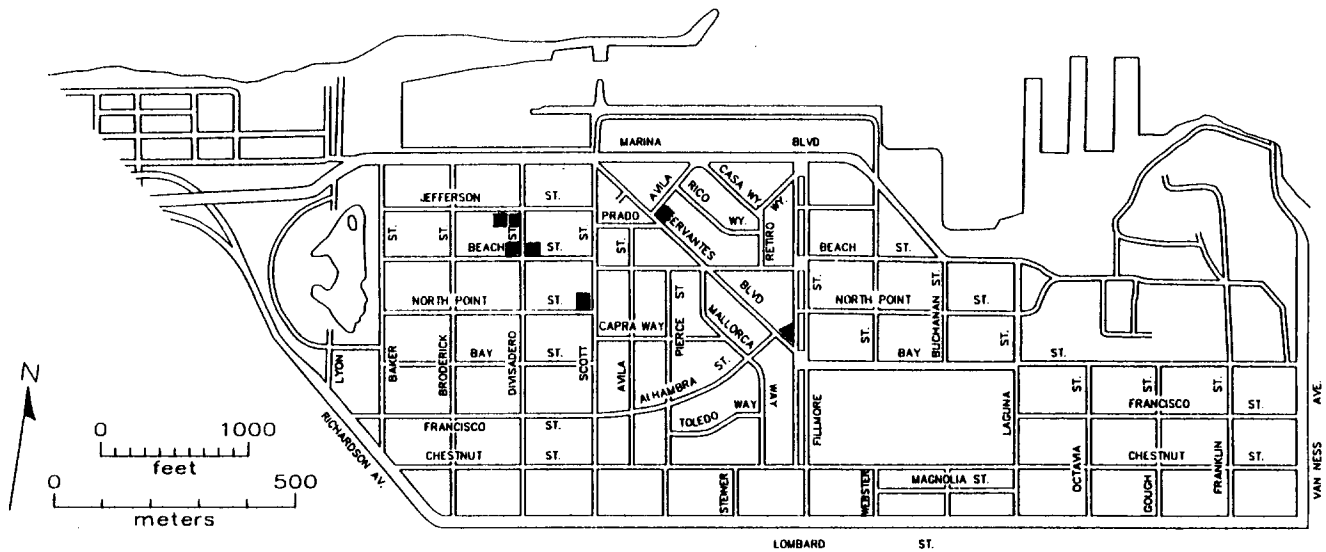
Figure 7.—Marina District, showing locations of collapsed buildings (dark areas). Base map from U.S. Geological Survey (1990).

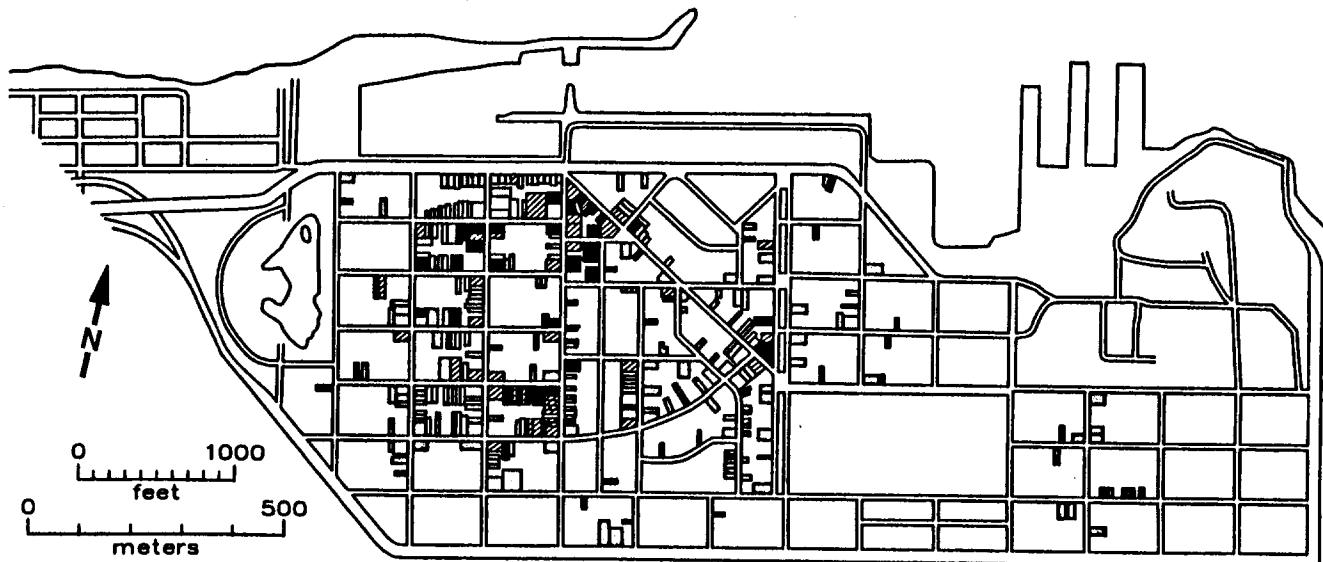
Figure 8.—Marina District, showing locations of damaged buildings. From Seekins and others (1990).

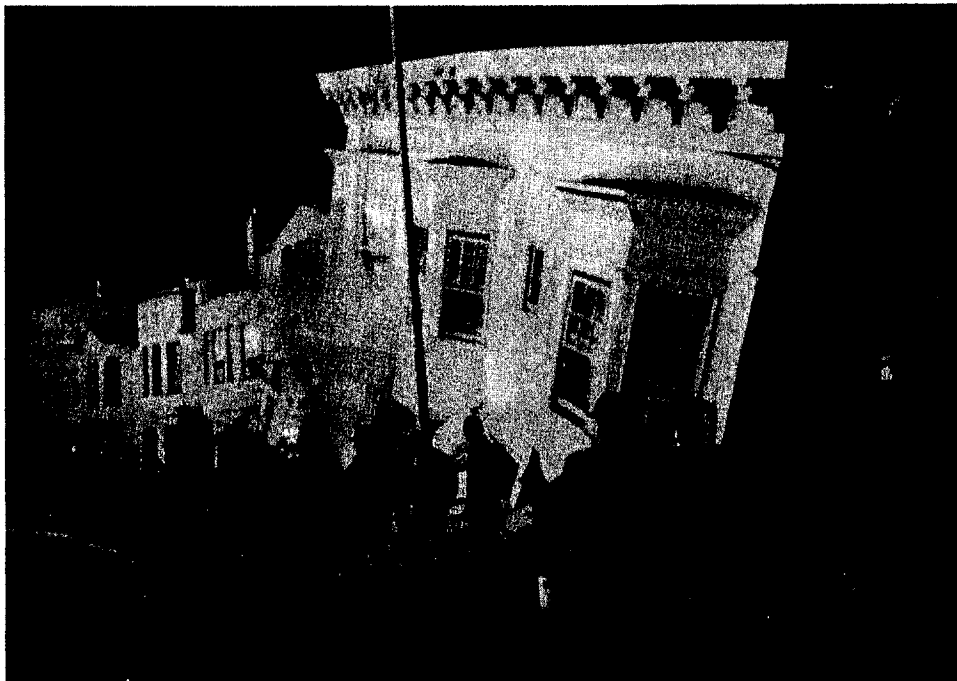
Figure 11.—Collapsed building at 2090 Beach Street, after fire was much advanced. Note firefighter directing water onto exposed side of building. Photograph by S.P. Harris, taken at about 7:00 p.m. P.d.t. October 17, 1989.

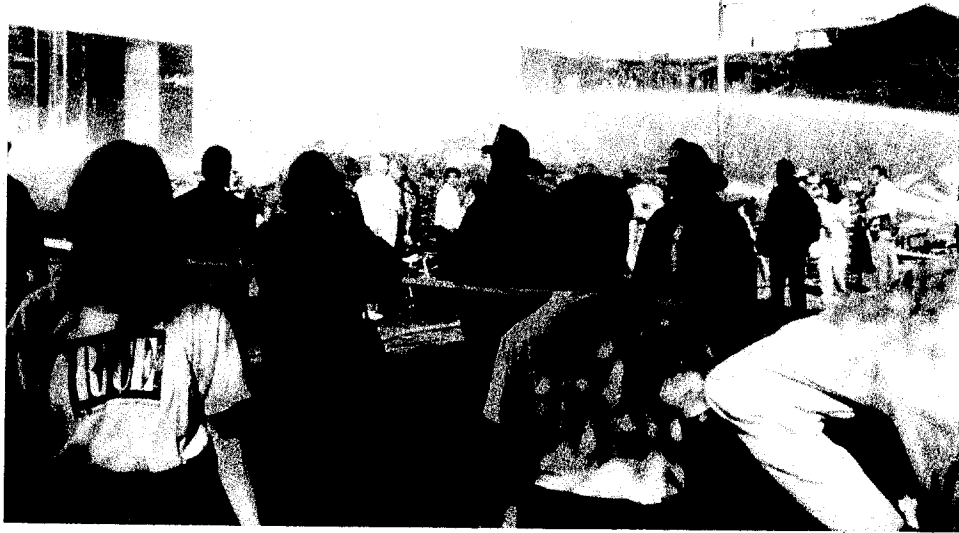
Figure 15.—Mopping-up operations on fire. Photograph taken October 18, 1989, from southeast corner of Beach and Divisadero Streets.

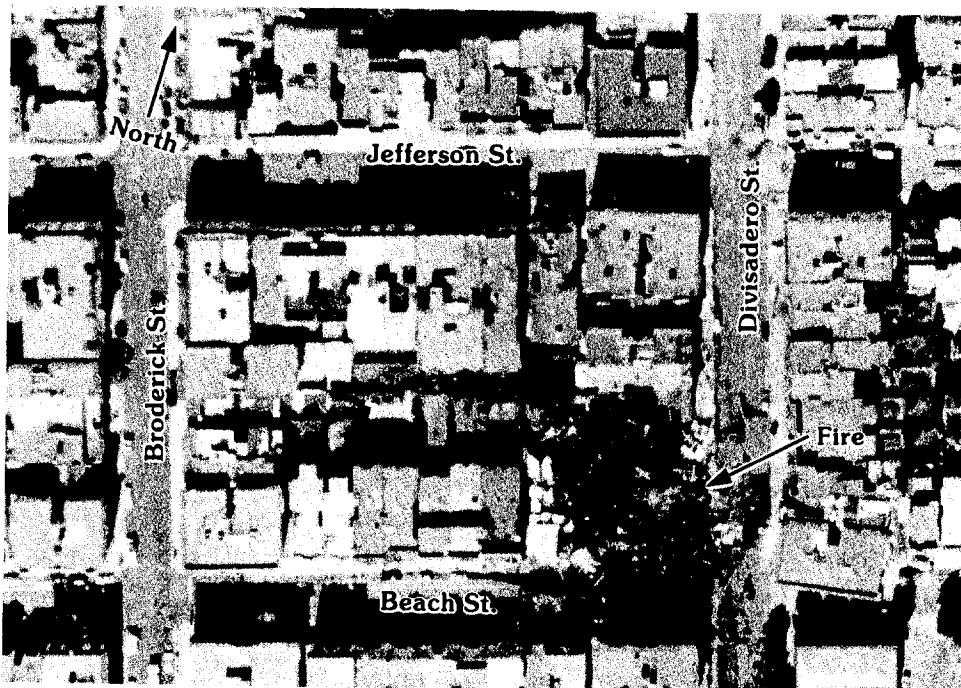
Relief began to come for the initial responders late into the night. Engine 41 was relieved around 11:30 p.m., and Engine 10 around midnight. Firefighters continued mopping-up operations for several days (fig. 15). The fire damaged seven structures, destroying four buildings containing 33 apartments and flats (Sanborn Map Co., 1988): 3701 Divisadero (21 apartments), 2130 Beach (12 apartments), 3717-19 Divisadero (2 flats), and 3723-25 Divisadero (2 flats). SFFD estimates place the losses from this fire at \$7.4 million (fig. 16).

Figure 16.—Northwestern part of Marina District, showing area near Beach and Divisadero Streets. Fire destroyed corner building, another immediately to west, and two more immediately to north.

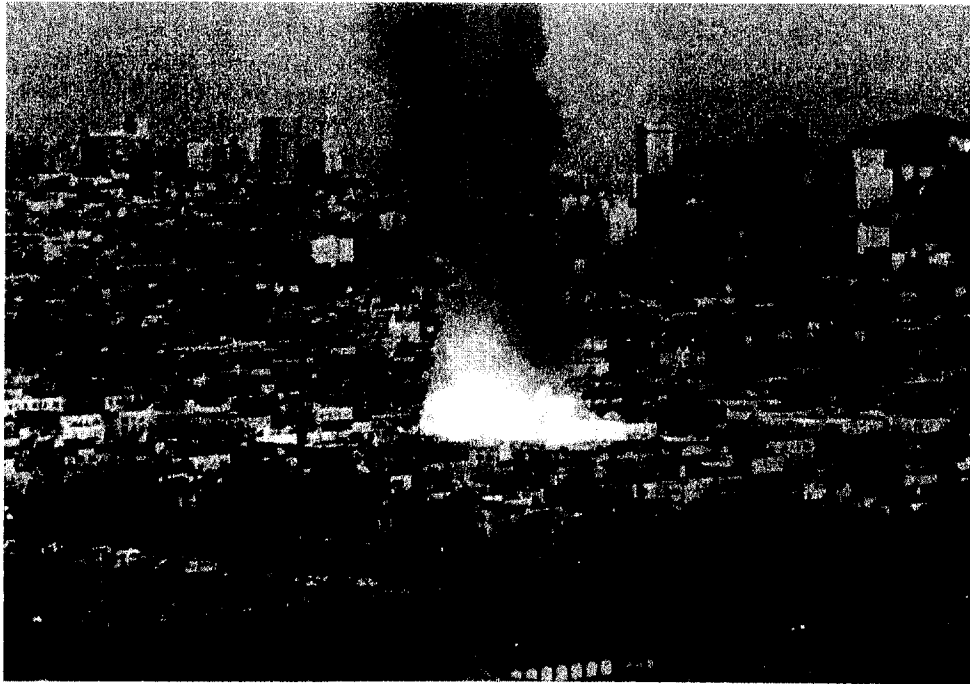
Figure 17.—Fire in the Marina District. Photograph by Martin Klimek, *Marin Independent Journal*, taken shortly after sunset October 17, 1989; view southeastward.
