# Personal Narrative of Events related to the Marina Fire<sup>1</sup> Loma Prieta Earthquake October 17, 1989

Charles Scawthorn, S.E.<sup>2</sup>

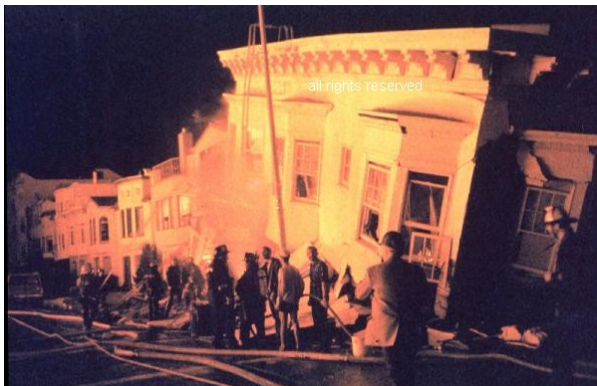
*Fig 1: Photo corner of Beach and Divisadero  
(author in foreground)*

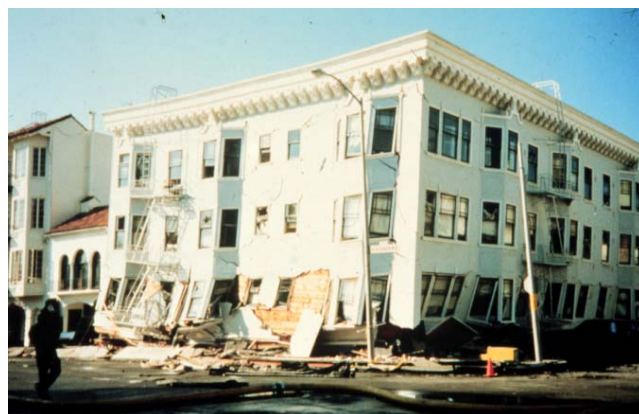
*Figure 2 - Collapse building SE corner Jefferson and Divisadero, next day (Photo: Scawthorn, 1989)*

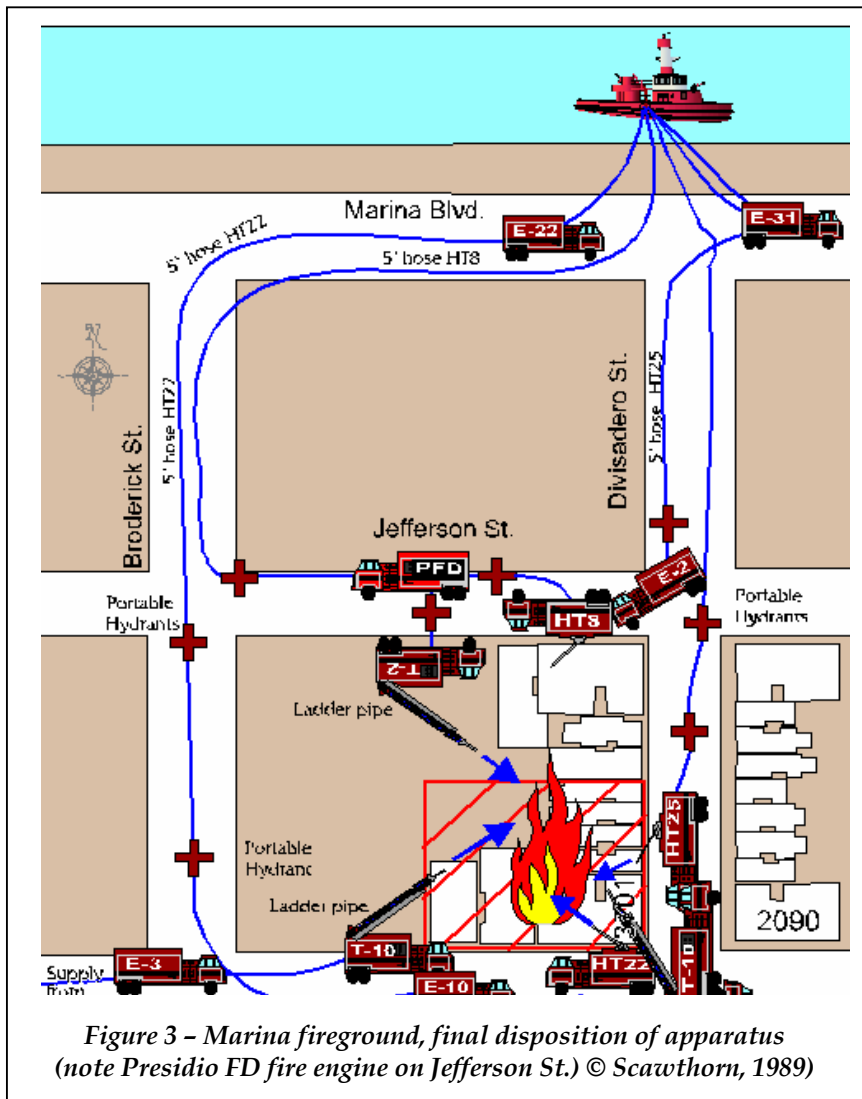
*“By the time we’d checked all the buildings, the Phoenix (which had come right to the seawall, intentionally grounding herself in order to do so) had passed multiple 3 inch lines across to the shore, and was pumping from the Marina (clogging her sea chests in the process) through her manifold into the 3 inch lines to gated wyes onshore, then into 5 inch lines which ran two blocks south to the PWSS hose tenders and fire engines, which then directed master streams onto the fire and exposures. By this Phoenix-PWSS (portable water supply system) combination, the master streams had a goodly supply of water such that the fire was soon under control, and the excitement dying down. It was quite obvious to me at the time that, while this fire was only about 250 yards from the shore and thus could have been supplied by more conventional fire hose-engine relays, if the fire had been a few more blocks further from the shore, only the PWSS would have been able to convey the water in adequate supply. Figure 1 shows the scene at about this time, with the buildings across the street brightly lit by the still burning (but under control) fire, while Figure 3 shows the arrangement of the Phoenix and equipment at about this time.*
