THE LOMA PRIETA, CALIFORNIA, EARTHQUAKE OF OCTOBER 17, 1989:  
STRONG GROUND MOTION AND GROUND FAILURE

MARINA DISTRICT

PERFORMANCE OF EMERGENCY-RESPONSE SERVICES  
AFTER THE EARTHQUAKE

By Charles R. Scawthorn and Keith A. Porter, EQE Engineering and Design; and  
Frank T. Blackburn, PWSS Co., Ltd.

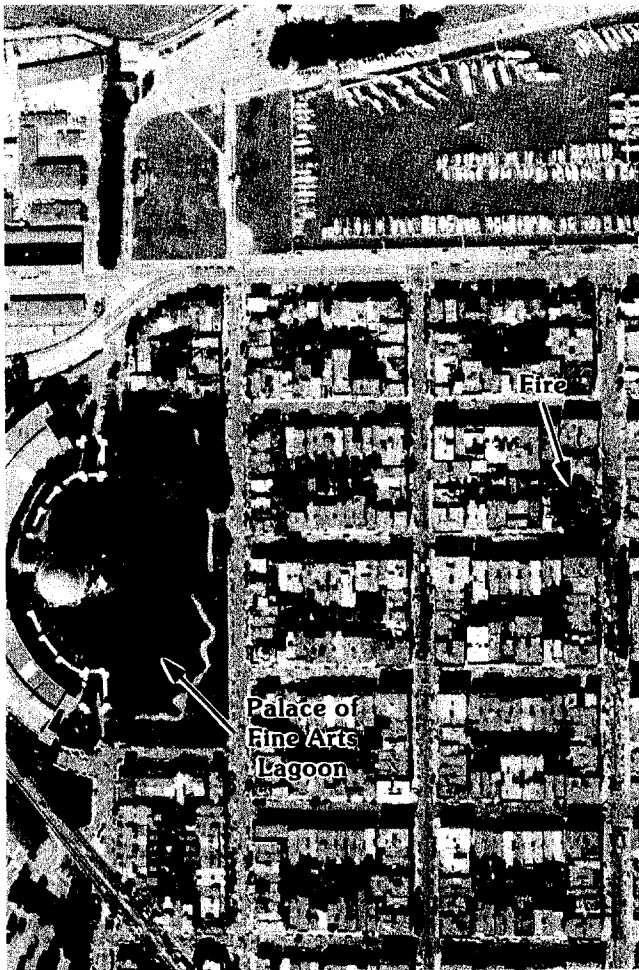
Engine 21 abandoned the AWSS hydrant and fixed on another source of water: the lagoon at the Palace of Fine Arts, just two blocks to the west (fig. 13). According to Capt. Costella's report:

Figure 13.—Western part of Marina District, showing location of fire relative to lagoon at the Palace of Fine Arts. Photograph taken October 18, 1989.

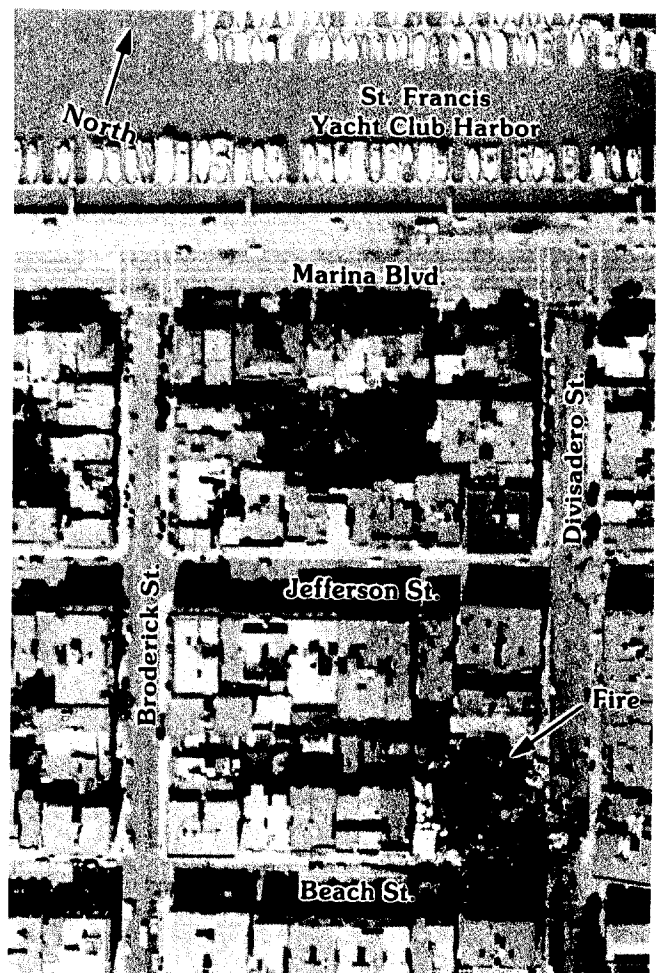
The now-complete crew of Hosetender 25 began immediately to make the initial 5-in.-diameter hose lead. It ran from Marina Boulevard up Divisadero Street to Beach Street and included two portable hydrants, with 900 ft of 5-in.-diameter hose. Hosetender 25 was then positioned on the east flank of the fire (fig. 14); from this position, they would be able to protect the buildings across, and farther north on, Divisadero Street.

Figure 14.—Northwestern part of Marina District, showing location of the St. Francis Yacht Club Harbor. Hosetender 25 was located immediately to right of fire. PWSS hose leads from yacht harbor are visible on Divisadero and Broderick Streets. Photograph taken October 18, 1989.

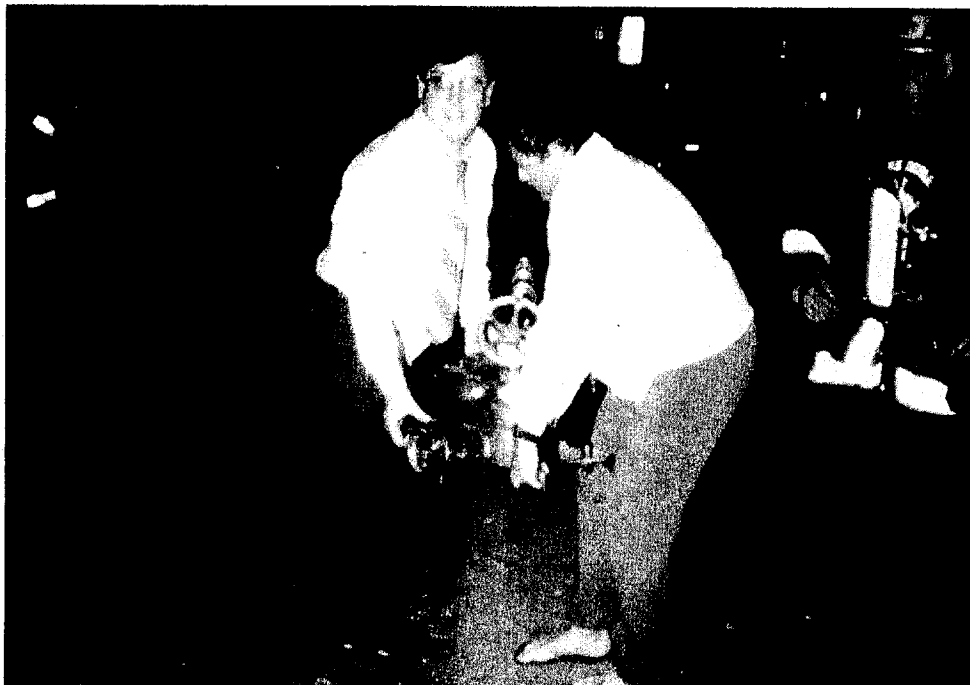
Indeed, there were plenty of volunteers (fig. 18). An off-duty police officer at home in his apartment on Divisadero Street near Beach Street felt the earthquake, took his daughter out of the building, went back inside to get his shield, and emerged again to take control of the area. Civil-

Figure 18.—Volunteers assisted SFFD at fire. Note firefighter at right. Photograph by C.R. Scawthorn.
